MEMORANDUM INTERMOUNTAIN POWER SERVICE CORPORATION INTERMOUNTAIN GENERATING STATION

SUBJECT: Follow up report regarding Cooling Tower Fan Blade

Resonance

SUBJECT: Follow up Report Concerning the Cooling Tower Fan Blade
Resonance and Ceramic Cooling Towers Proposed use of a Ten Blade Fan System

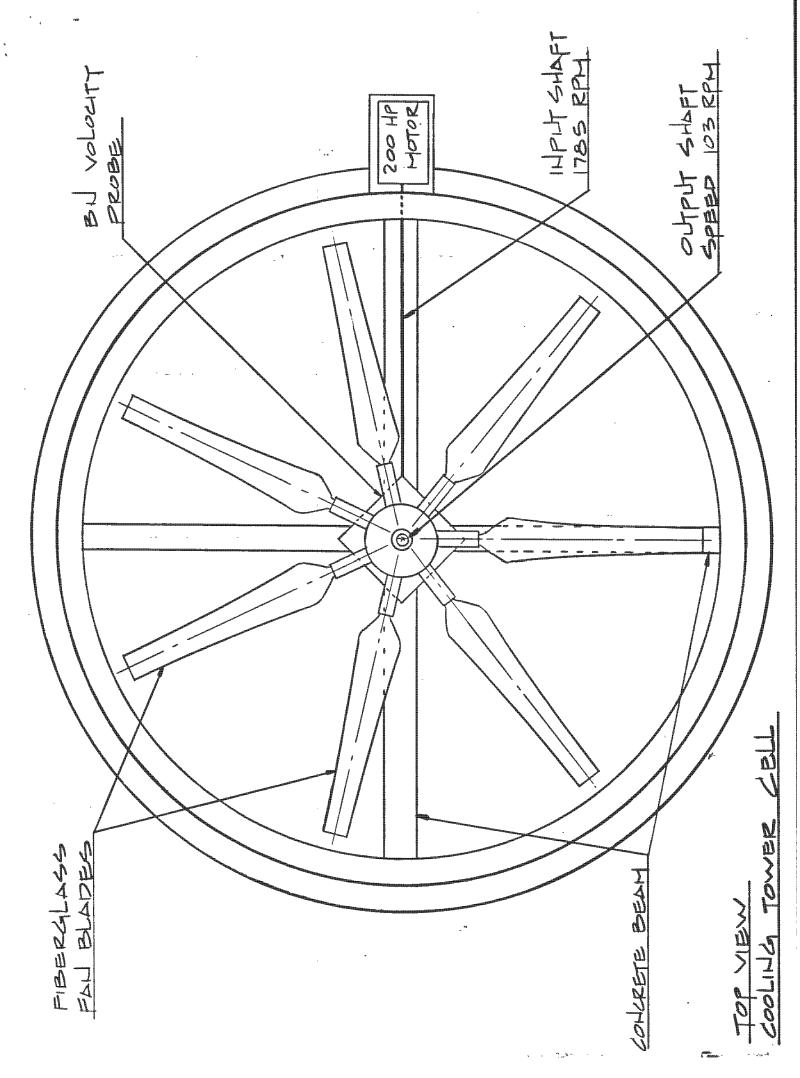
PICTURE # 1

Fan cell 1A03 was selected for this special vibration test because of several tripping problems due to a blade droop switch being activated. Acceleration probes were mounted at the end of three of the seven blades, (see picture #1). A cable was then run from the probe to a recorder and power system, which were mounted in the center of the fan hub, (see pictures 2 thur 5). A key phaser was also attached to the fan hub and referenced to a point on the gear reducer. With this unique setup, vibration data concerning the blade movement could be obtained while the fan was in operation.

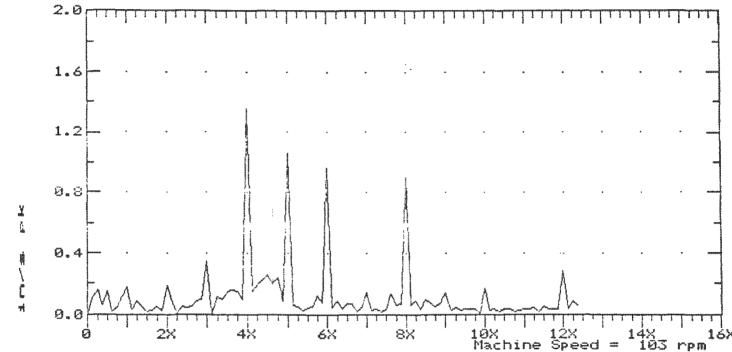
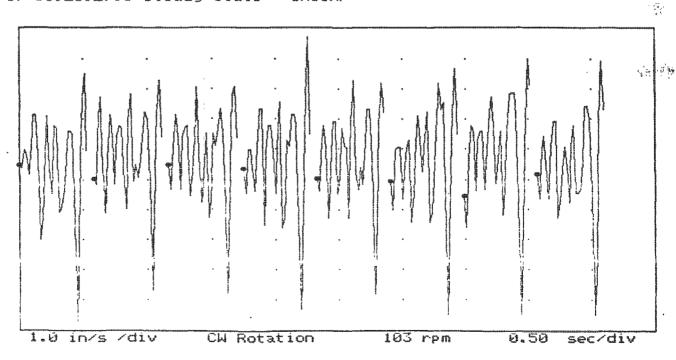
CH# 1 Blade # 1

The data gathered first was the result of a fan static condition, while air was short circuited through the dormant cell. As attachment 1 indicates the three blades were being excited at natural blade resonance, 412 cpm. Attachment two indicates the signal waveform of the three blades as the fan was in operation. The waveforms have been integrated from acceleration to velocity with the ADRE 3 Data Acquisition System. All values indicated in these plots should be multiplied by a factor of 10. Attachment 2 indicates very clearly that each blade was being excited four times during each revolution. Other minor spikes in the waveform indicate reaction to other blades moving in the fan system, thus creating a fan hub wobble. Signature traces, cascade plots, and careful attention to the key phase reference mark in attachments 3 - 6, bear this last comment out. The probe on blade # 5 was damaged shortly into the test, so data was not available.
